ADDENDUM NO. 3

**Replace Roofs
Guhleman Forensic Complex
Fulton State Hospital
Fulton, Missouri
PROJECT NO.: M1906-01**

Limited Mold Sampling Report

Guhleman Forensic Center
Cremer Activities Building
689 Route O
Fulton, Missouri

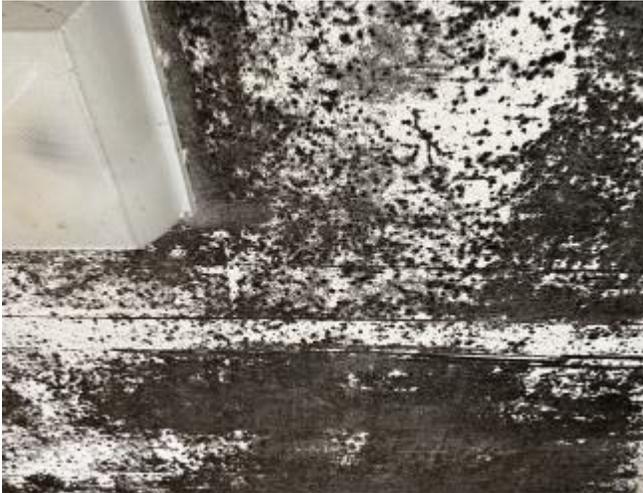
Photo 3 Center of Ceiling

The ceiling of the I-shaped roof at the southeast part of the Cremer Activities Building, Guhleman Forensic Center was observed to be impacted by microbial growth. Observation of the ceiling identified suspect microbial growth. Laboratory analysis of the tape lift samples indicated that the wall samples from the porch roof contained high levels of *Cladosporium* (with fruiting structures and/or hyphae).

- Remove moldy building materials where damaged beyond cleaning and clean any remaining substrate with soap and water.
- Reassess the area to determine the effectiveness of the cleaning or material removal.
- Consider hiring a remediation contractor to perform the work (not required by any regulation).
