ADDENDUM NO. 3

**Replace Roofs
Guhleman Forensic Complex
Fulton State Hospital
Fulton, Missouri
PROJECT NO.: M1906-01**

Limited Mold Sampling Report

**LIMITED MOLD SURVEY OF
CREMER ACTIVITIES BUILDING ENTRANCE ROOF
Guhleman Forensic Center
689 Route O, Fulton, Missouri**

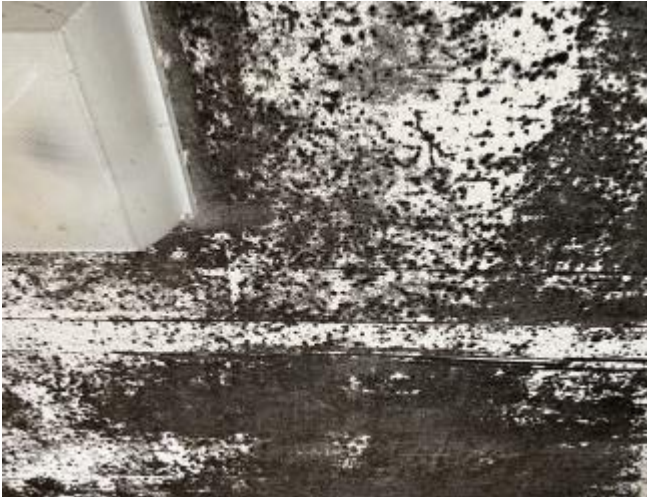
Photo 3 Center of Ceiling

The ceiling of the I-shaped roof at the southeast part of the Cremer Activities Building, Guhleman Forensic Center was observed to be impacted by microbial growth. Observation of the ceiling identified suspect microbial growth. Laboratory analysis of the tape lift samples indicated that the wall samples from the porch roof contained high levels of *Cladosporium* (with fruiting structures and/or hyphae).

- Remove moldy building materials where damaged beyond cleaning and clean any remaining substrate with soap and water.
- Reassess the area to determine the effectiveness of the cleaning or material removal.
- Consider hiring a remediation contractor to perform the work (not required by any regulation).
