ADDENDUM NO. 1

**Window Replacement
Administration Building – Wheeler Hall
Missouri School for the Deaf
Fulton, Missouri
PROJECT NO.: E1906-01**

Window Replacement, Administration Building – Wheeler Hall

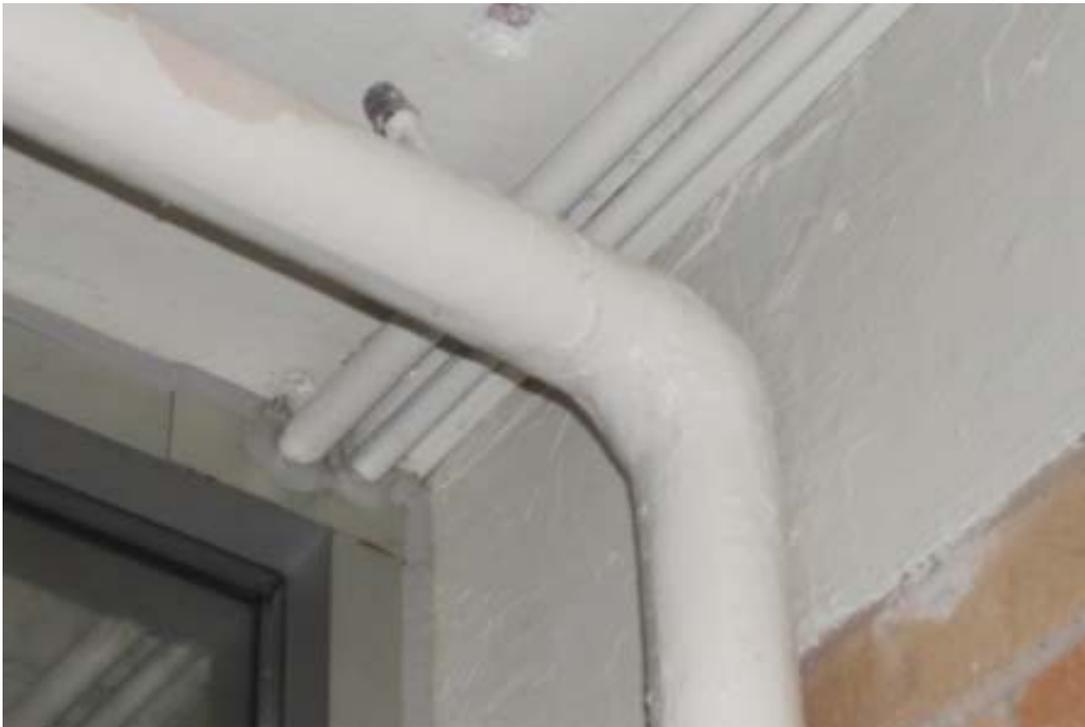
HM #8, Asbestos-Containing White Mudded Pipe Fittings

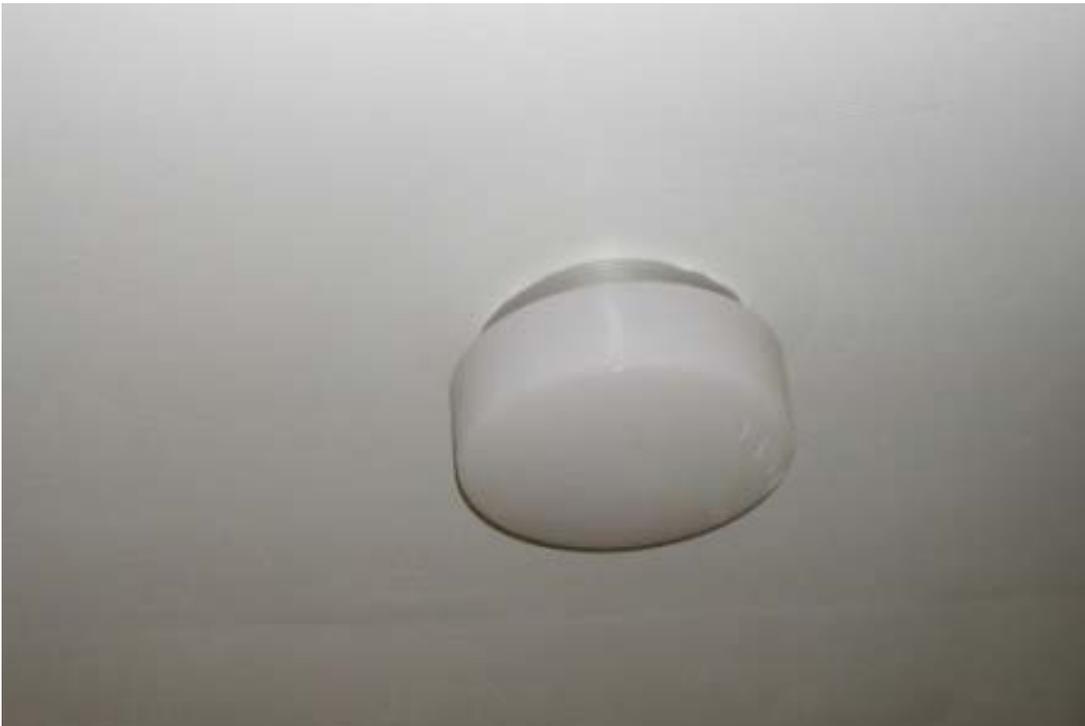
HM #9, Asbestos-Containing Light Reflector Paper

Material Description		Material Number	Asbestos Present	
Light Reflector Paper		LRP-09	Yes	
Material Category	Friable Classification	EPA Category	Total Quantity	Unit of Measurement
Good	Friable	Friable	30	Square Feet
General Condition	Overall Material Assessment	Recommended Response		
Good	Potential for Damage/No Damage	Operations & Maintenance

Material Location(s)	Floor	Location Quantity	Location Condition	Material Comments (by location)
Vault	1	1	Good	
Women's Office Restroom	1	1	Good	
North Corridor	1	11	Good	
East Stairwell	1	4	Good	
Vestibule	1	1	Good	
Women's Restroom 1	1	2	Good	
West Stairwell	1	2	Good	
Room 204 Closet	2	1	Good	
Men's Office Restroom	1	1	Good	
Men's Restroom 1	1	2	Good	1 Exposed
Women's Restroom 2	2	2	Good	
Men's Restroom 2	2	2	Good

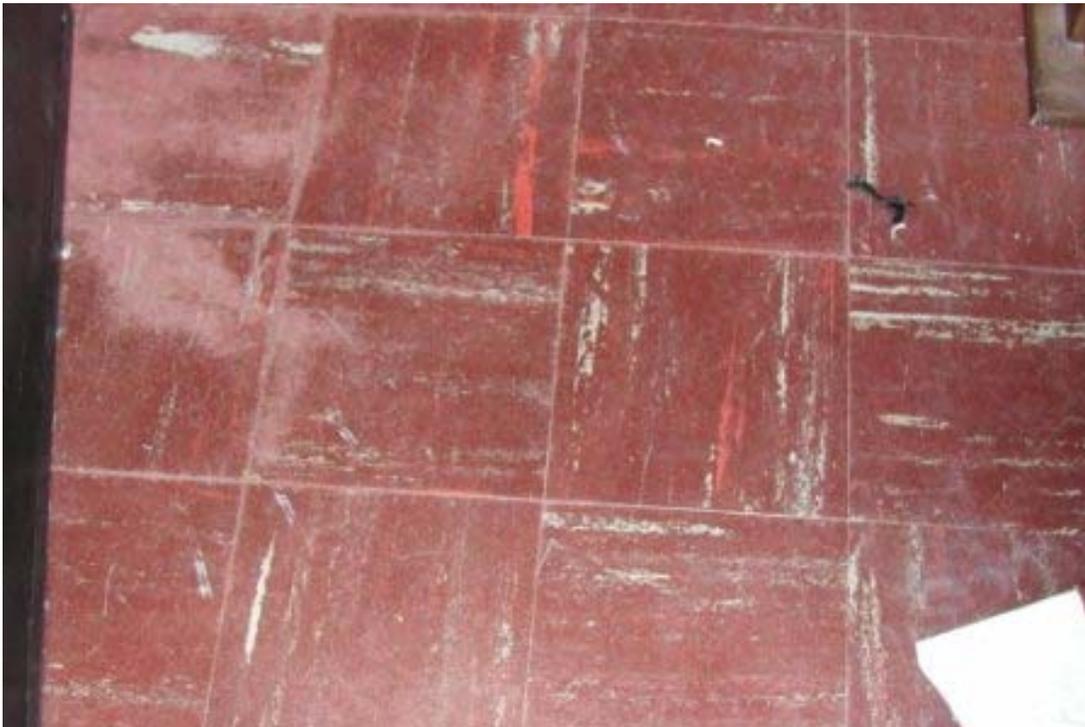
HM #13, Asbestos-Containing 9" x 9" Brown Floor Tile and Mastic

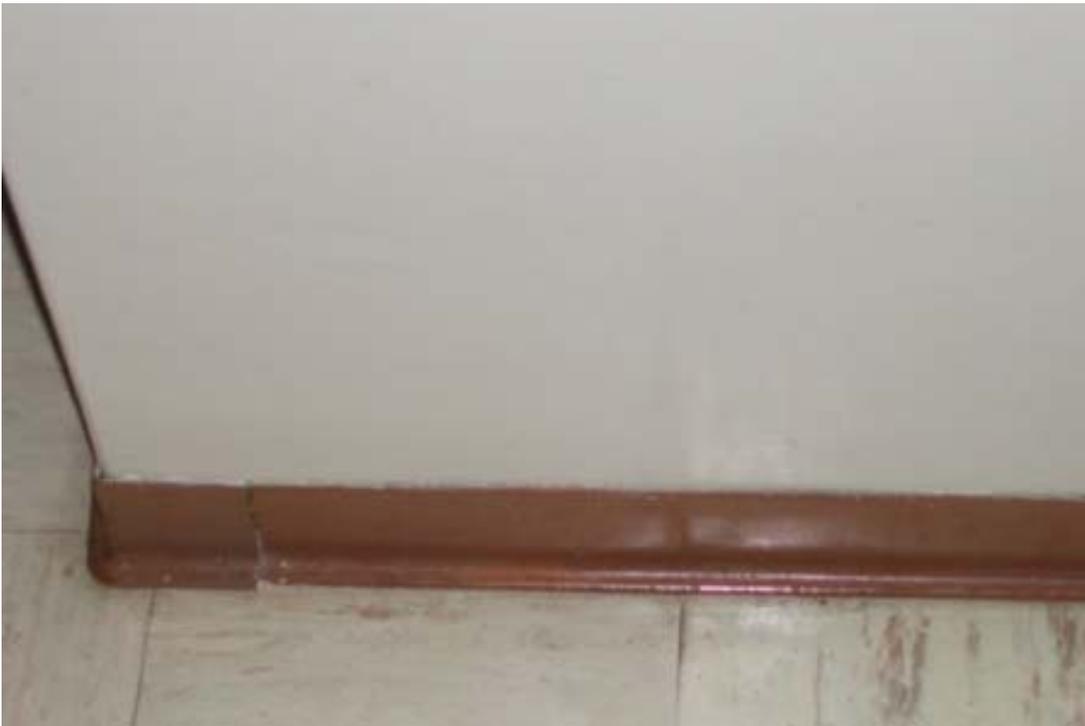
HM #14, Asbestos-Containing 9" x 9" Beige Floor Tile and Mastic

Material Description		Material Number	Asbestos Present	
9" Beige Floor Tile & Mastic		FTM-14	Yes	
Material Category	Friable Classification	EPA Category	Total Quantity	Unit of Measurement
Flooring	Non-Friable	Category I	1,662	Square Feet
General Condition	Overall Material Assessment	Recommended Response		
Good	Potential for Damage/No Damage	Operations & Maintenance		
General Material Comments

Material Location(s)	Floor	Location Quantity	Location Condition	Material Comments (by location)
Restroom 3	2	35	Good	
Office 2	2	250	Good	Under Carpet
Restroom 2	2	35	Good

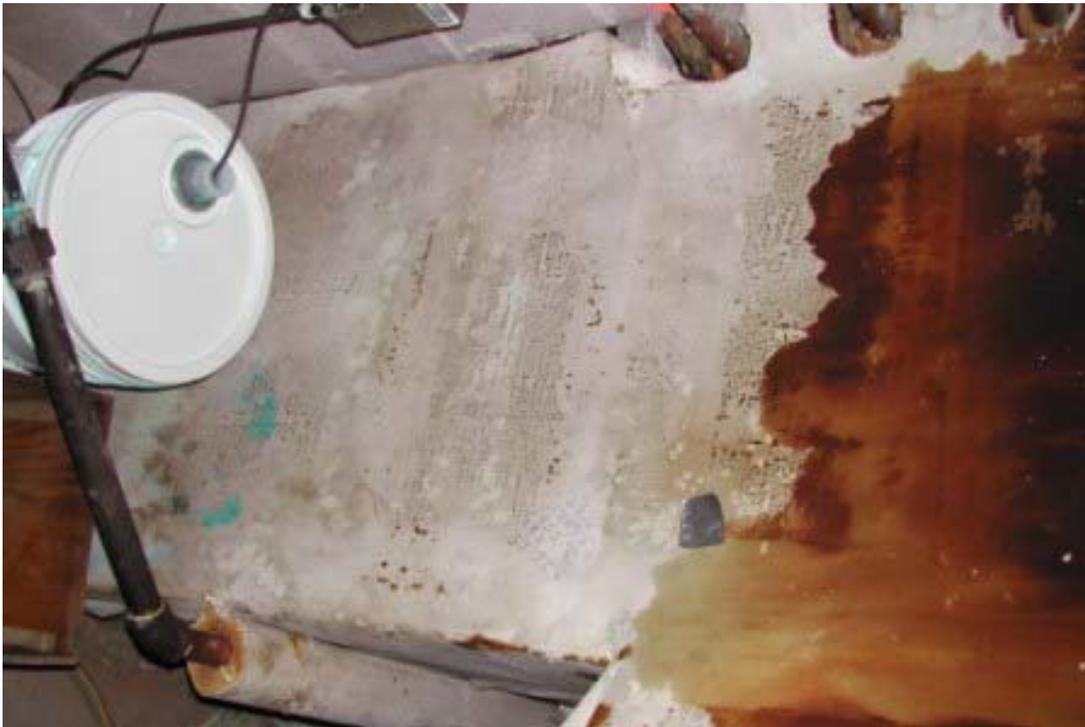
HM #18, Asbestos-Containing Duct Insulation

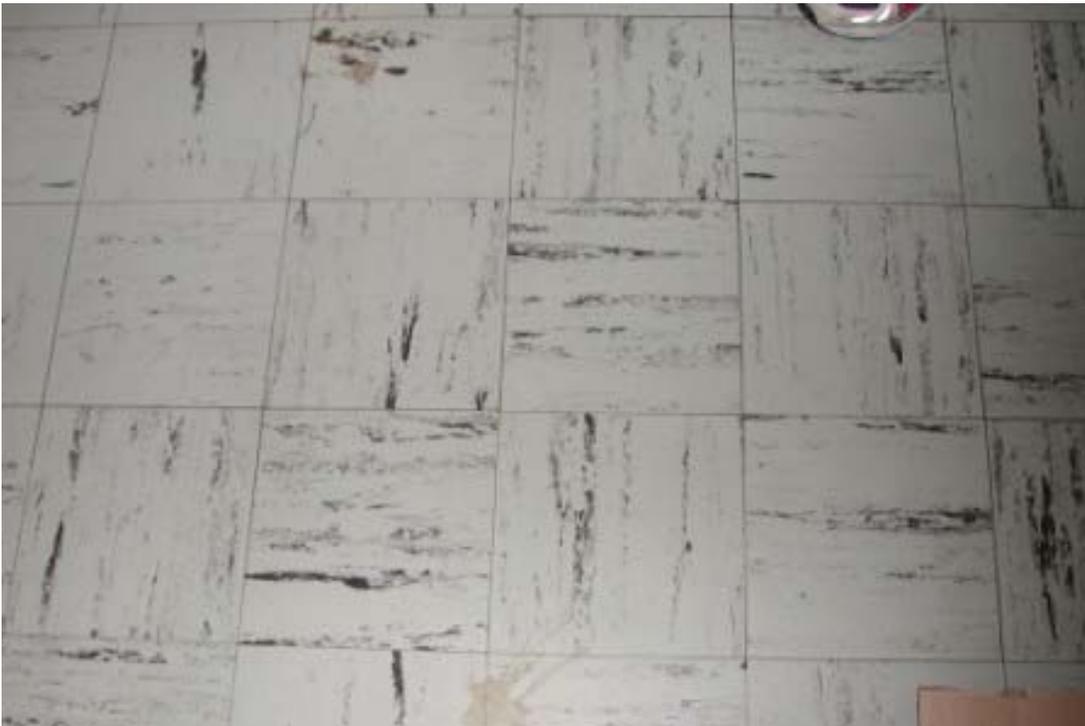
HM #19, Asbestos-Containing 9" x 9" White w/Black Floor Tile and Mastic

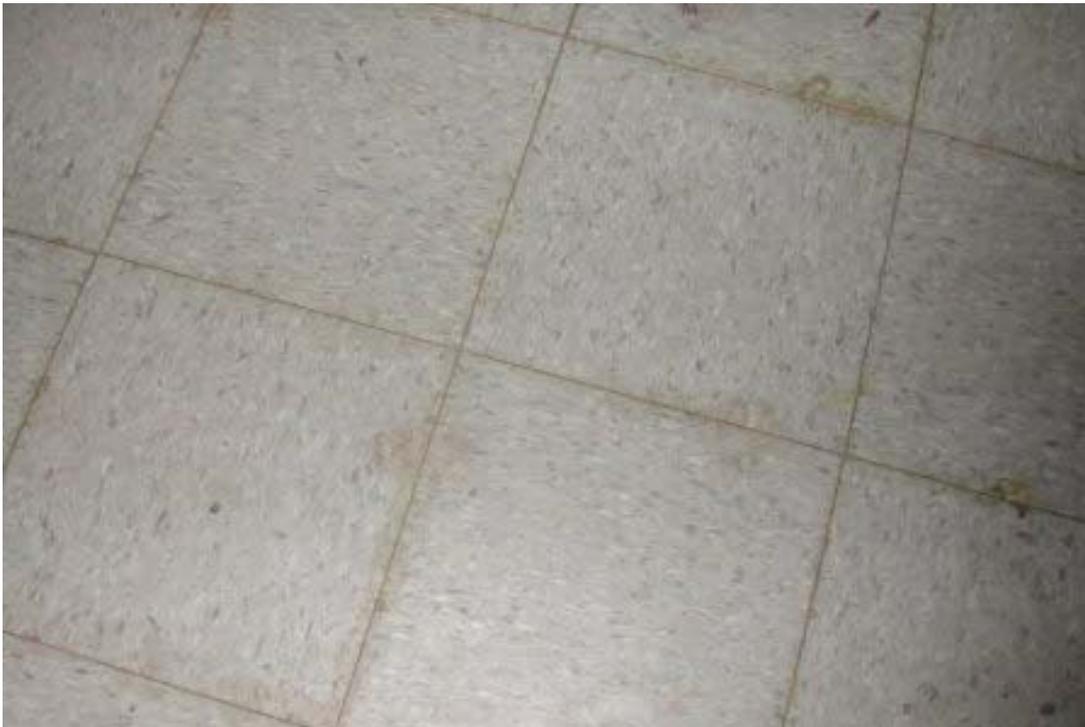
HM #25, Asbestos-Containing 12" x 12" Beige and Grey Floor Tile and Mastic

Material Description		Material Number	Asbestos Present	
12x12" Beige & Grey Floor Tile & Mastic		FTM-25	Yes	
Material Category	Friable Classification	EPA Category	Total Quantity	Unit of Measurement
Flooring	Non-Friable	Category I	780	Square Feet
General Condition	Overall Material Assessment	Recommended Response		
Good	Potential for Damage/No Damage	Operations & Maintenance		
General Material Comments

Material Location(s)	Floor	Location Quantity	Location Condition	Material Comments (by location)	
Laboratory Room 106	1	780	Good	10 SF tile removed exposing mastic	
Sample IDs/Location	Floor	Analyzed	Overall Result	Layer(s) reported by lab	Results by Layer
FTM-25-383055 Laboratory Room 106	1	Yes	5%	1) Floor Tile 2) Mastic	None Detected 5% Chrysotile
FTM-25-383056 Laboratory Room 106	1	Yes	0%	1) Floor Tile 2) Mastic	None Detected Not Analyzed
FTM-25-383057 Laboratory Room 106	1	Yes	0%	1) Floor Tile 2) Mastic	None Detected Not Analyzed

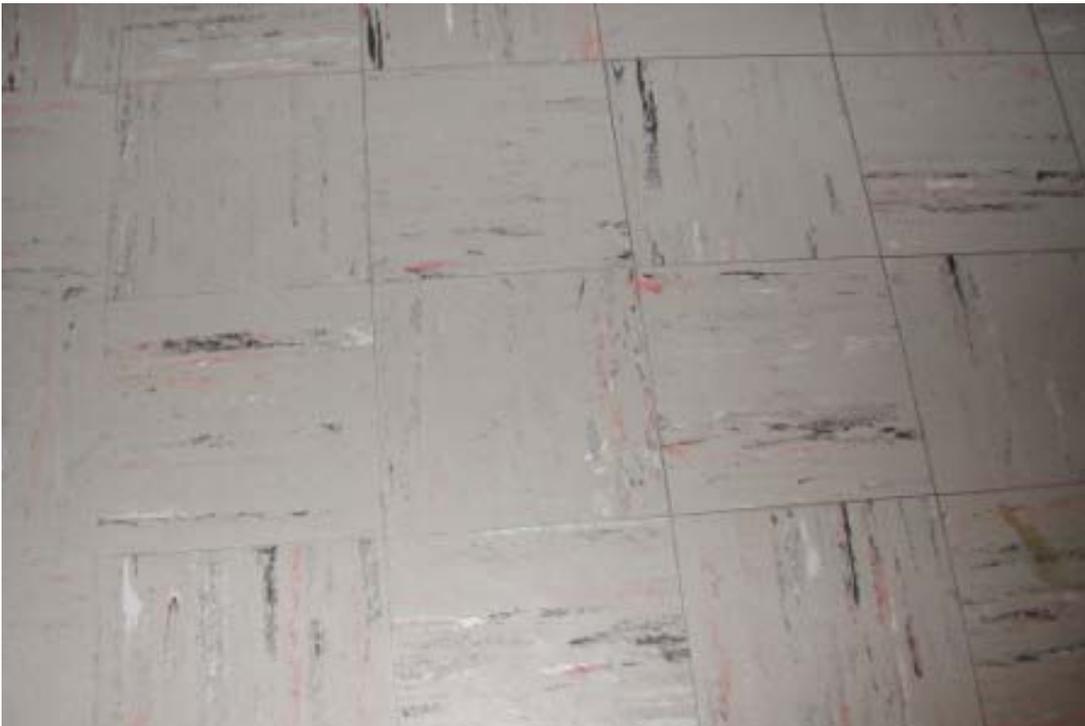
HM #26, Asbestos-Containing 9" x 9" Grey w/Black and Orange Streaks Floor Tile & Mastic

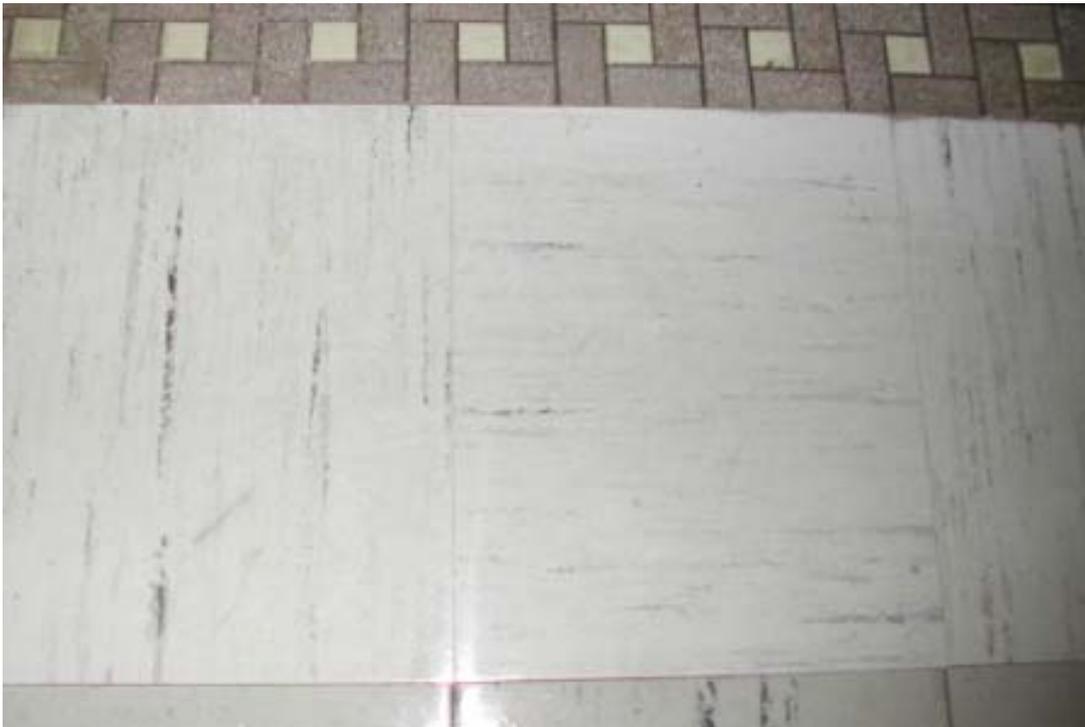
HM #32, Asbestos-Containing 10" x 12" White w/Grey Floor Tile and Mastic

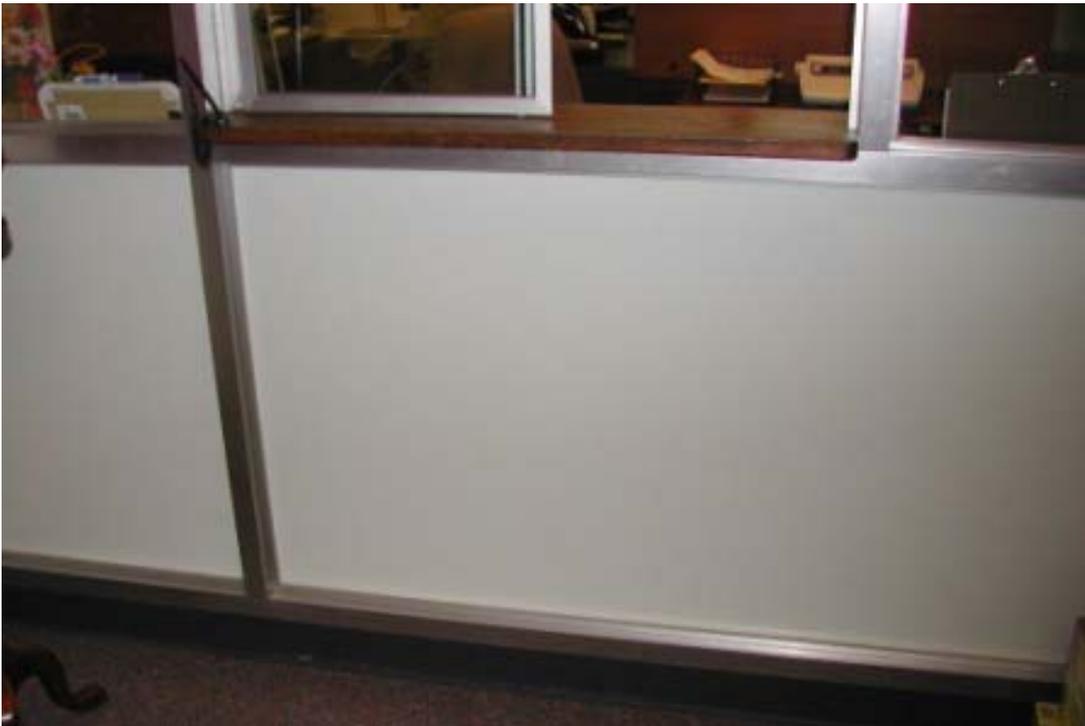
HM #35, Assumed Asbestos-Containing Transite Panel

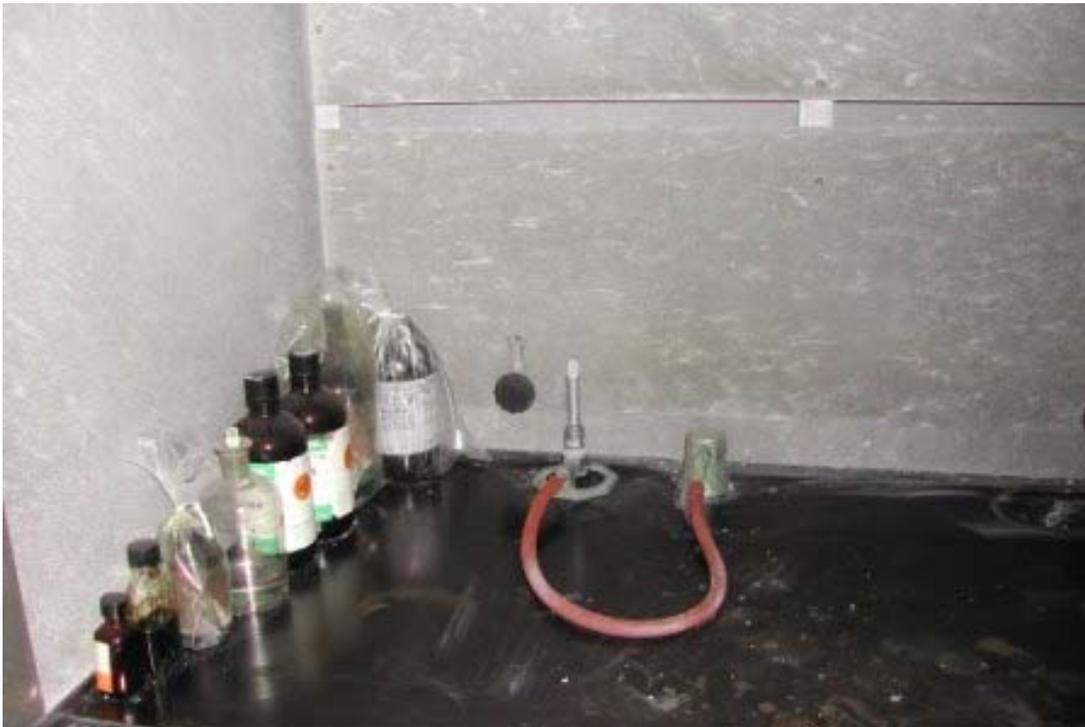
HM #36, Assumed Asbestos-Containing Transite Panel Fume Hood

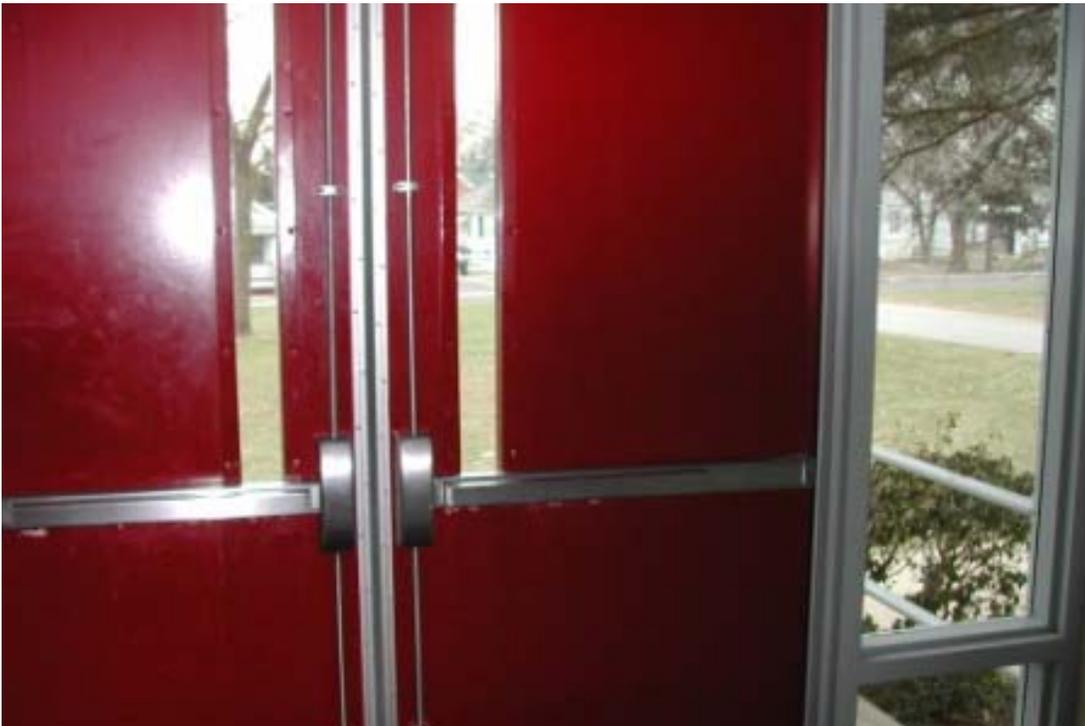
HM #37, Assumed Asbestos-Containing Fire Door

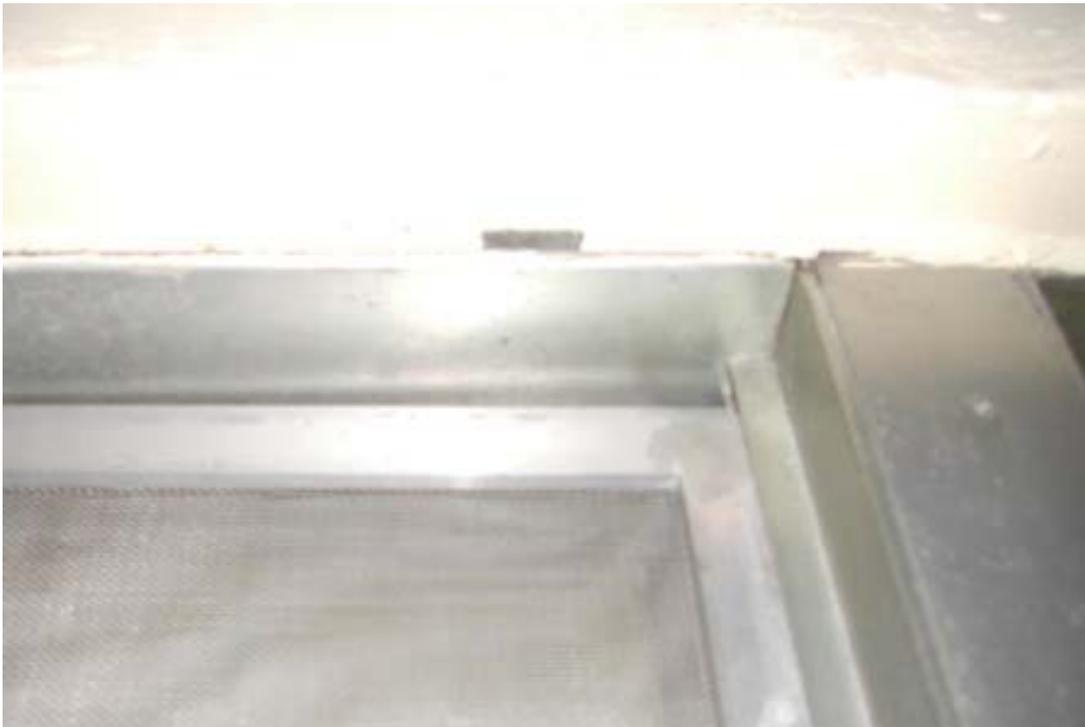
HM #40, **Asbestos-Containing** Grey Window Misc Caulking Material

Material Description		Material Number	Asbestos Present	
Grey Window Misc Caulking Material		CAULK-40/63	Yes	
Material Category	Friable Classification	EPA Category	Total Quantity	Unit of Measurement
Miscellaneous	Non-Friable	Category I	3,147	Linear Feet
General Condition	Overall Material Assessment	Recommended Response		
Good	Potential for Damage/No Damage	Operations & Maintenance

Material Location(s)	Floor	Location Quantity	Location Condition	Material Comments (by location)
Art Room	B	33	Good	
North Exterior	EXT	587	Fair	
North Exterior	EXT	862	Fair	
North Corridor	1	192	Good	
South Exterior	EXT	587	Good	
South Exterior	EXT	862	Good	
West Exterior	EXT	12	Good	
West Exterior	EXT	12	Good

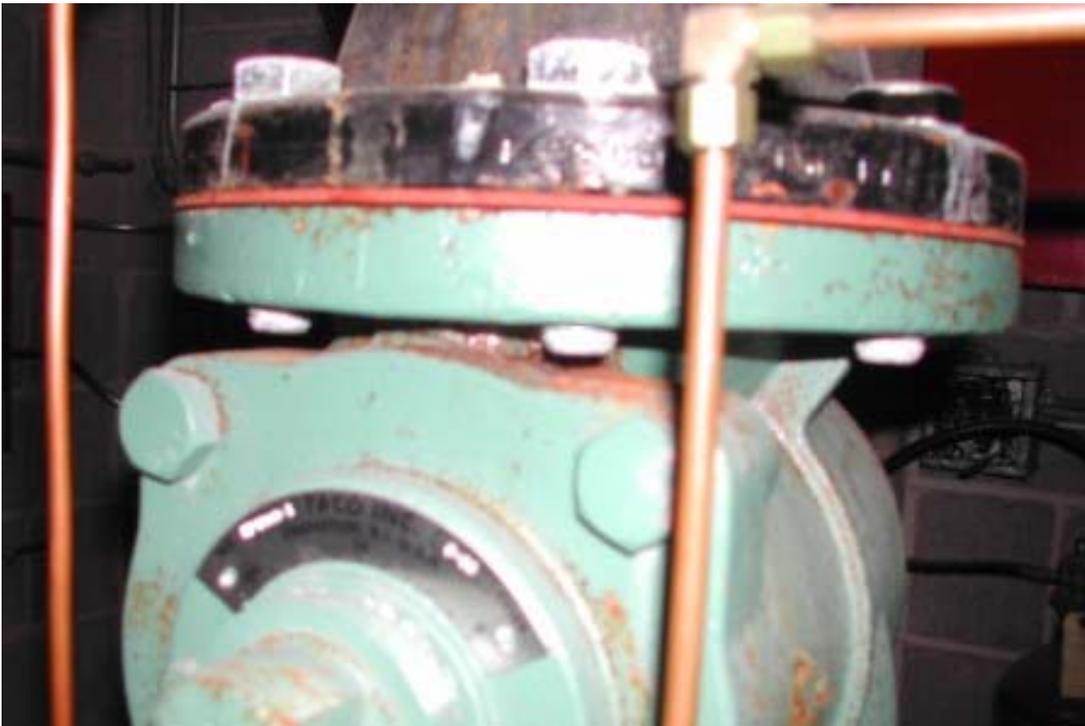
HM #43, **Assumed Asbestos-Containing** Gasket Material

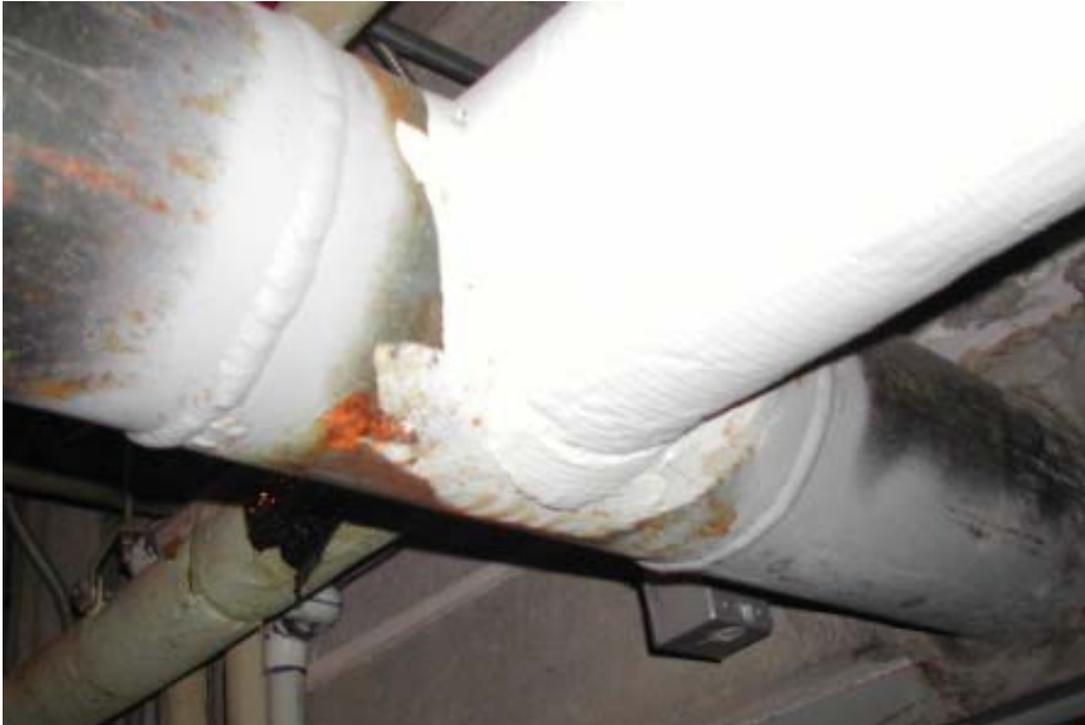
HM #44, Asbestos-Containing White Pipe Mastic

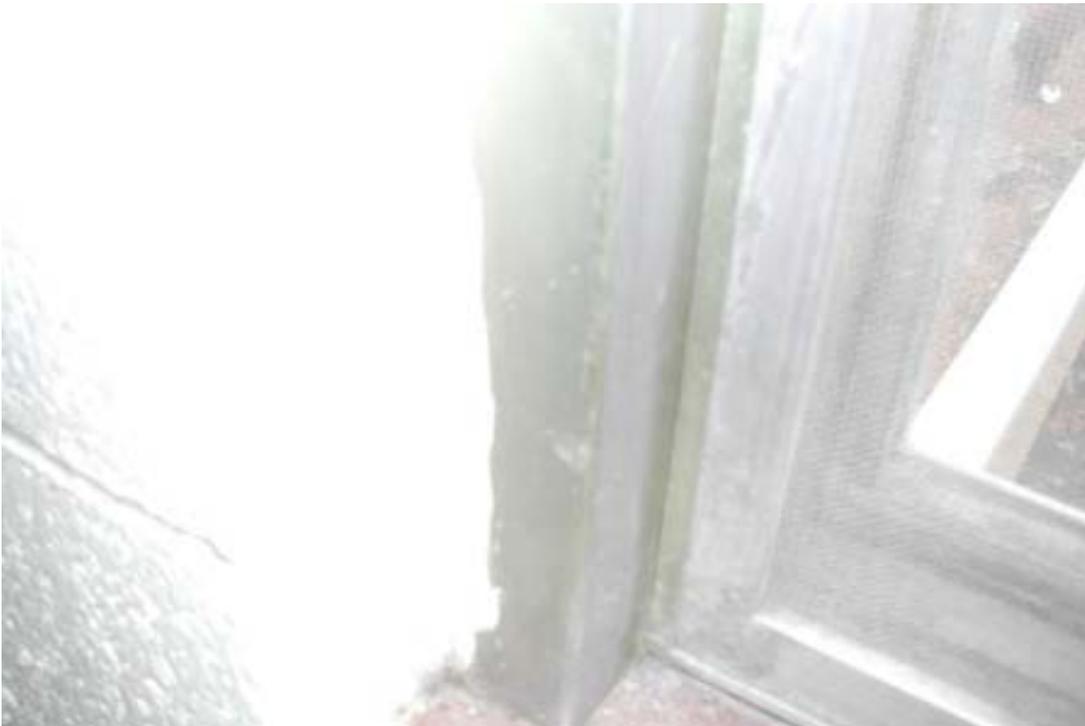
HM #45, Asbestos-Containing White Window Misc Caulking Material

Material Description		Material Number	Asbestos Present	
White Window Misc Caulking Material		CAULK-45	Yes	
Material Category	Friable Classification	EPA Category	Total Quantity	Unit of Measurement
Miscellaneous	Non-Friable	Category I	1,972	Linear Feet
General Condition	Overall Material Assessment	Recommended Response		
Good	Potential for Damage/No Damage	Operations & Maintenance

Material Location(s)	Floor	Location Quantity	Location Condition	Material Comments (by location)
Reception Area	2	72	Good	
Office 3	2	48	Fair	
Office 2	2	36	Fair	
East Stairwell	1	48	Good	
Receptionist Office	1	18	Good	
Room 109	1	48	Fair	
Nurse's Office	1	24	Fair	
Women's Restroom	1	16	Good

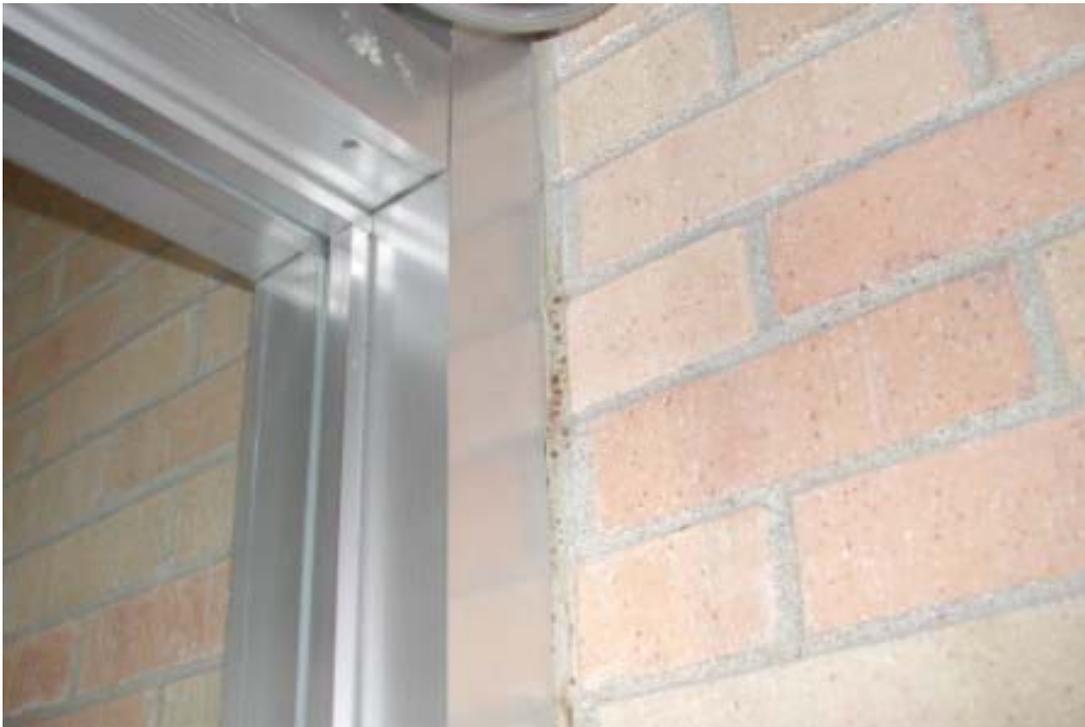
HM #55, Asbestos-Containing Grey Door Misc Caulking Material

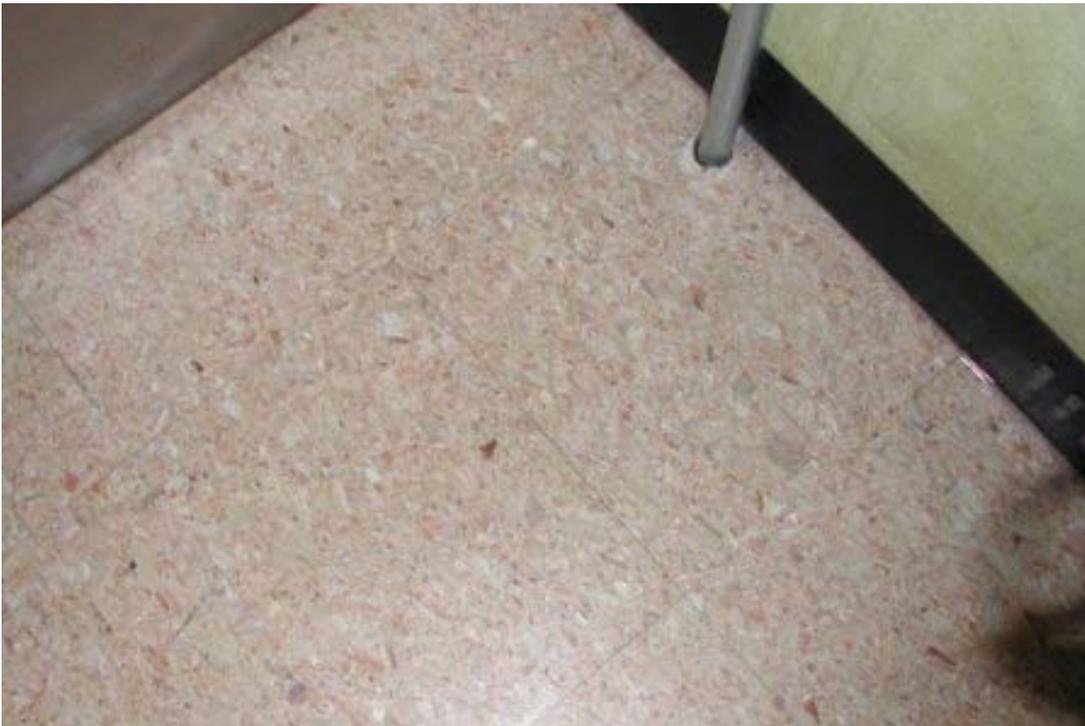
HM #57, Asbestos-Containing 12" x 12' Brown Wood Chip Floor Tile and Mastic

Material Description		Material Number	Asbestos Present	
12x12" Brown Wood Chip Floor Tile & Mastic		FTM-57	Yes	
Material Category	Friable Classification	EPA Category	Total Quantity	Unit of Measurement
Flooring	Non-Friable	Category I	30	Square Feet
General Condition	Overall Material Assessment	Recommended Response		
Good	Potential for Damage/No Damage	Operations & Maintenance		
General Material Comments

Material Location(s)	Floor	Location Quantity	Location Condition	Material Comments (by location)	
Elevator	1	30	Good		
Sample IDs/Location	Floor	Analyzed	Overall Result	Layer(s) reported by lab	Results by Layer
FTM-57-1 Elevator East Center	1	Yes	7%	1) Floor Tile	7% Chrysotile

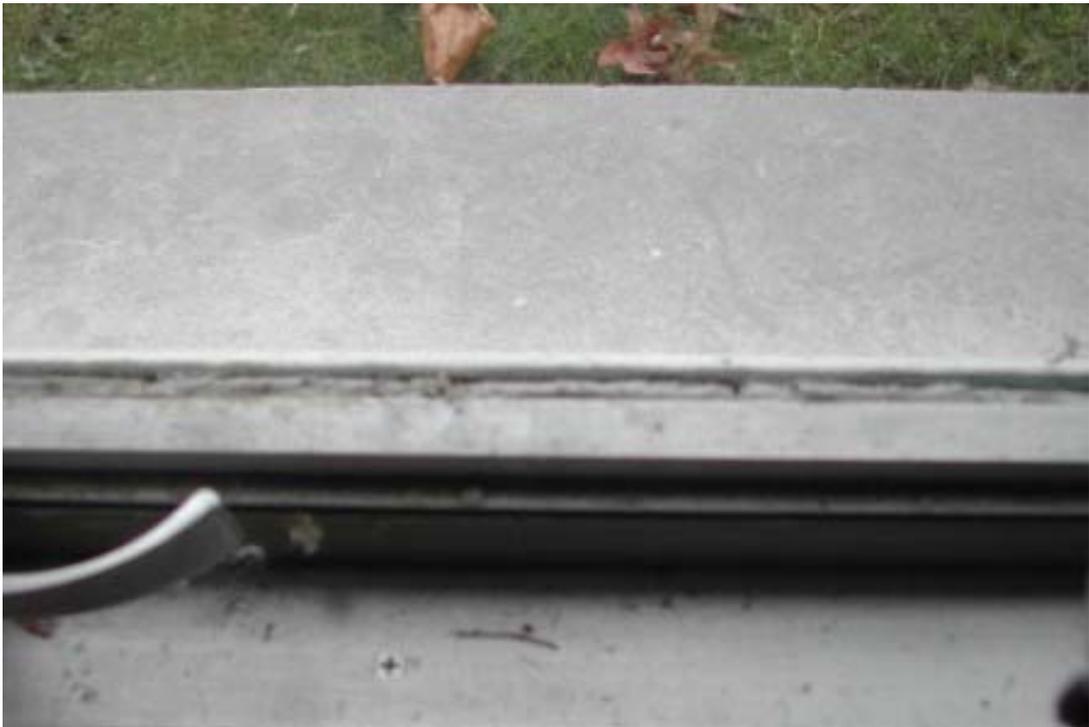
HM #60, Asbestos-Containing White Window Glazing

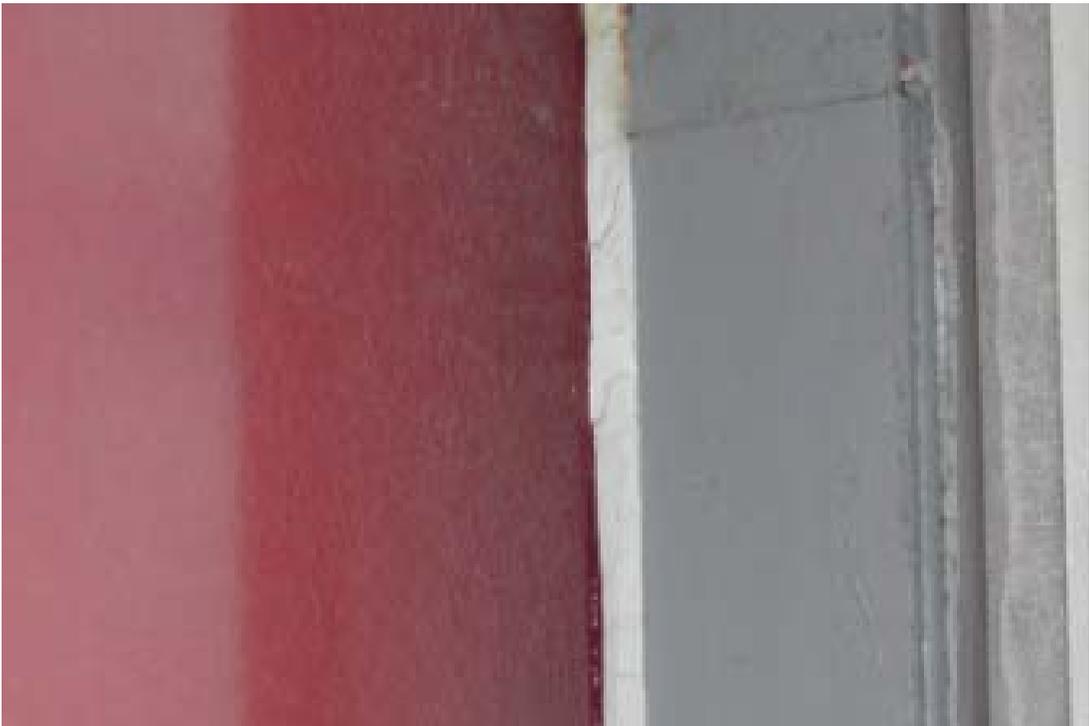
HM #61, Asbestos-Containing Beige Misc Caulking Material on Metal Panels

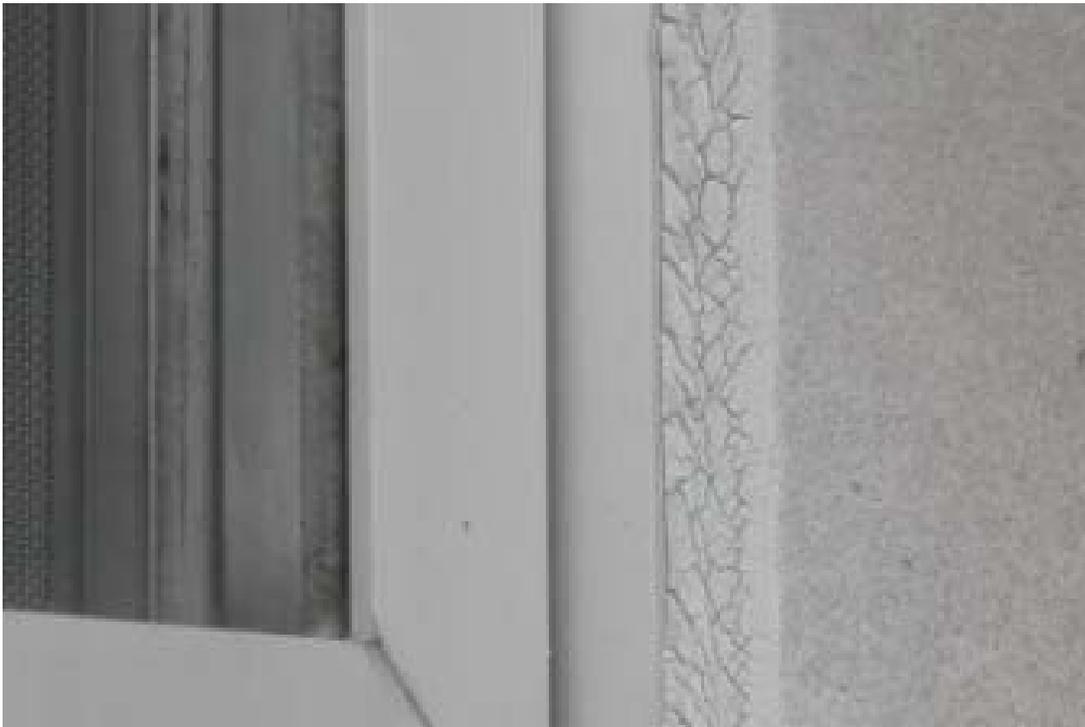
HM #63, **Asbestos-Containing** Grey Window Misc Caulking Material on Sashes

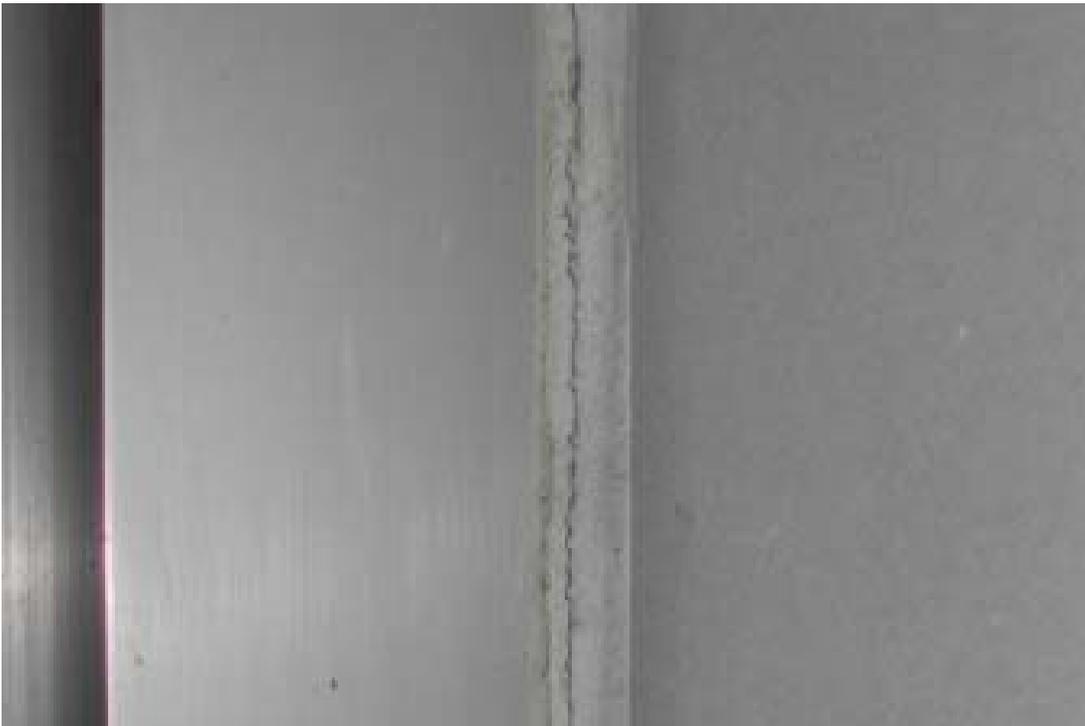
HM #64, **Asbestos-Containing** White Door Misc Caulking Material

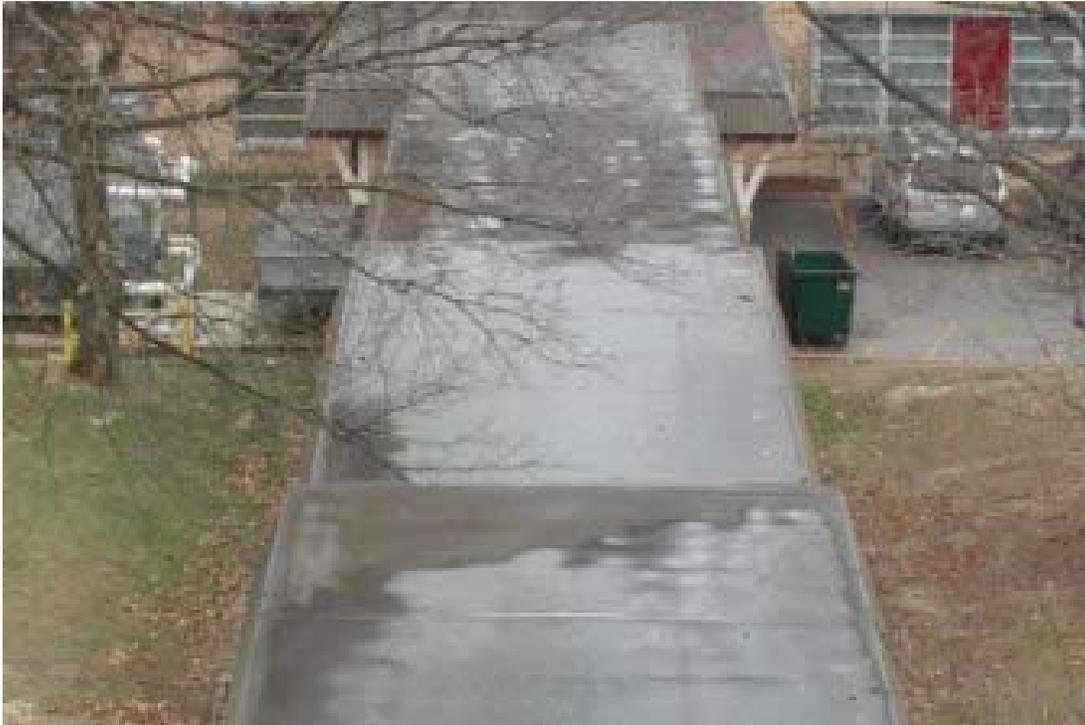
HM #66, Assumed Asbestos-Containing Black Roofing Material
