REPAIR TO HISTORIC STRUCTURE J. HUSTON TAVERN ARROW ROCK STATE HISTORIC SITE ARROW ROCK, MISSOURI

BID DOCUMENTS

PROJECT NUMBER: X2501-01

ORDER	SHEET NO.	TITLE OF SHEET
1	G-001	COVER SHEET
2	G-002	DRAWING INDEX & MAPS
3	A-101	TAVERN FIRST FLOOR PLAN
4	A-102	TAVERN SECOND FLOOR PLAN
5	A-201	TAVERN NORTH ELEVATION
6	A-202	TAVERN SOUTH ELEVATION
7	A-203	TAVERN EAST ELEVATION
8	A-204	TAVERN WEST ELEVATION
9	A-501	WINDOW DETAILS - 1830s/ 1840s ERA
10	A-502	WINDOW DETAILS - 1920s/ 1950s 1850s/ 1880s ERA SIM
11	A-503	DOOR DETAILS

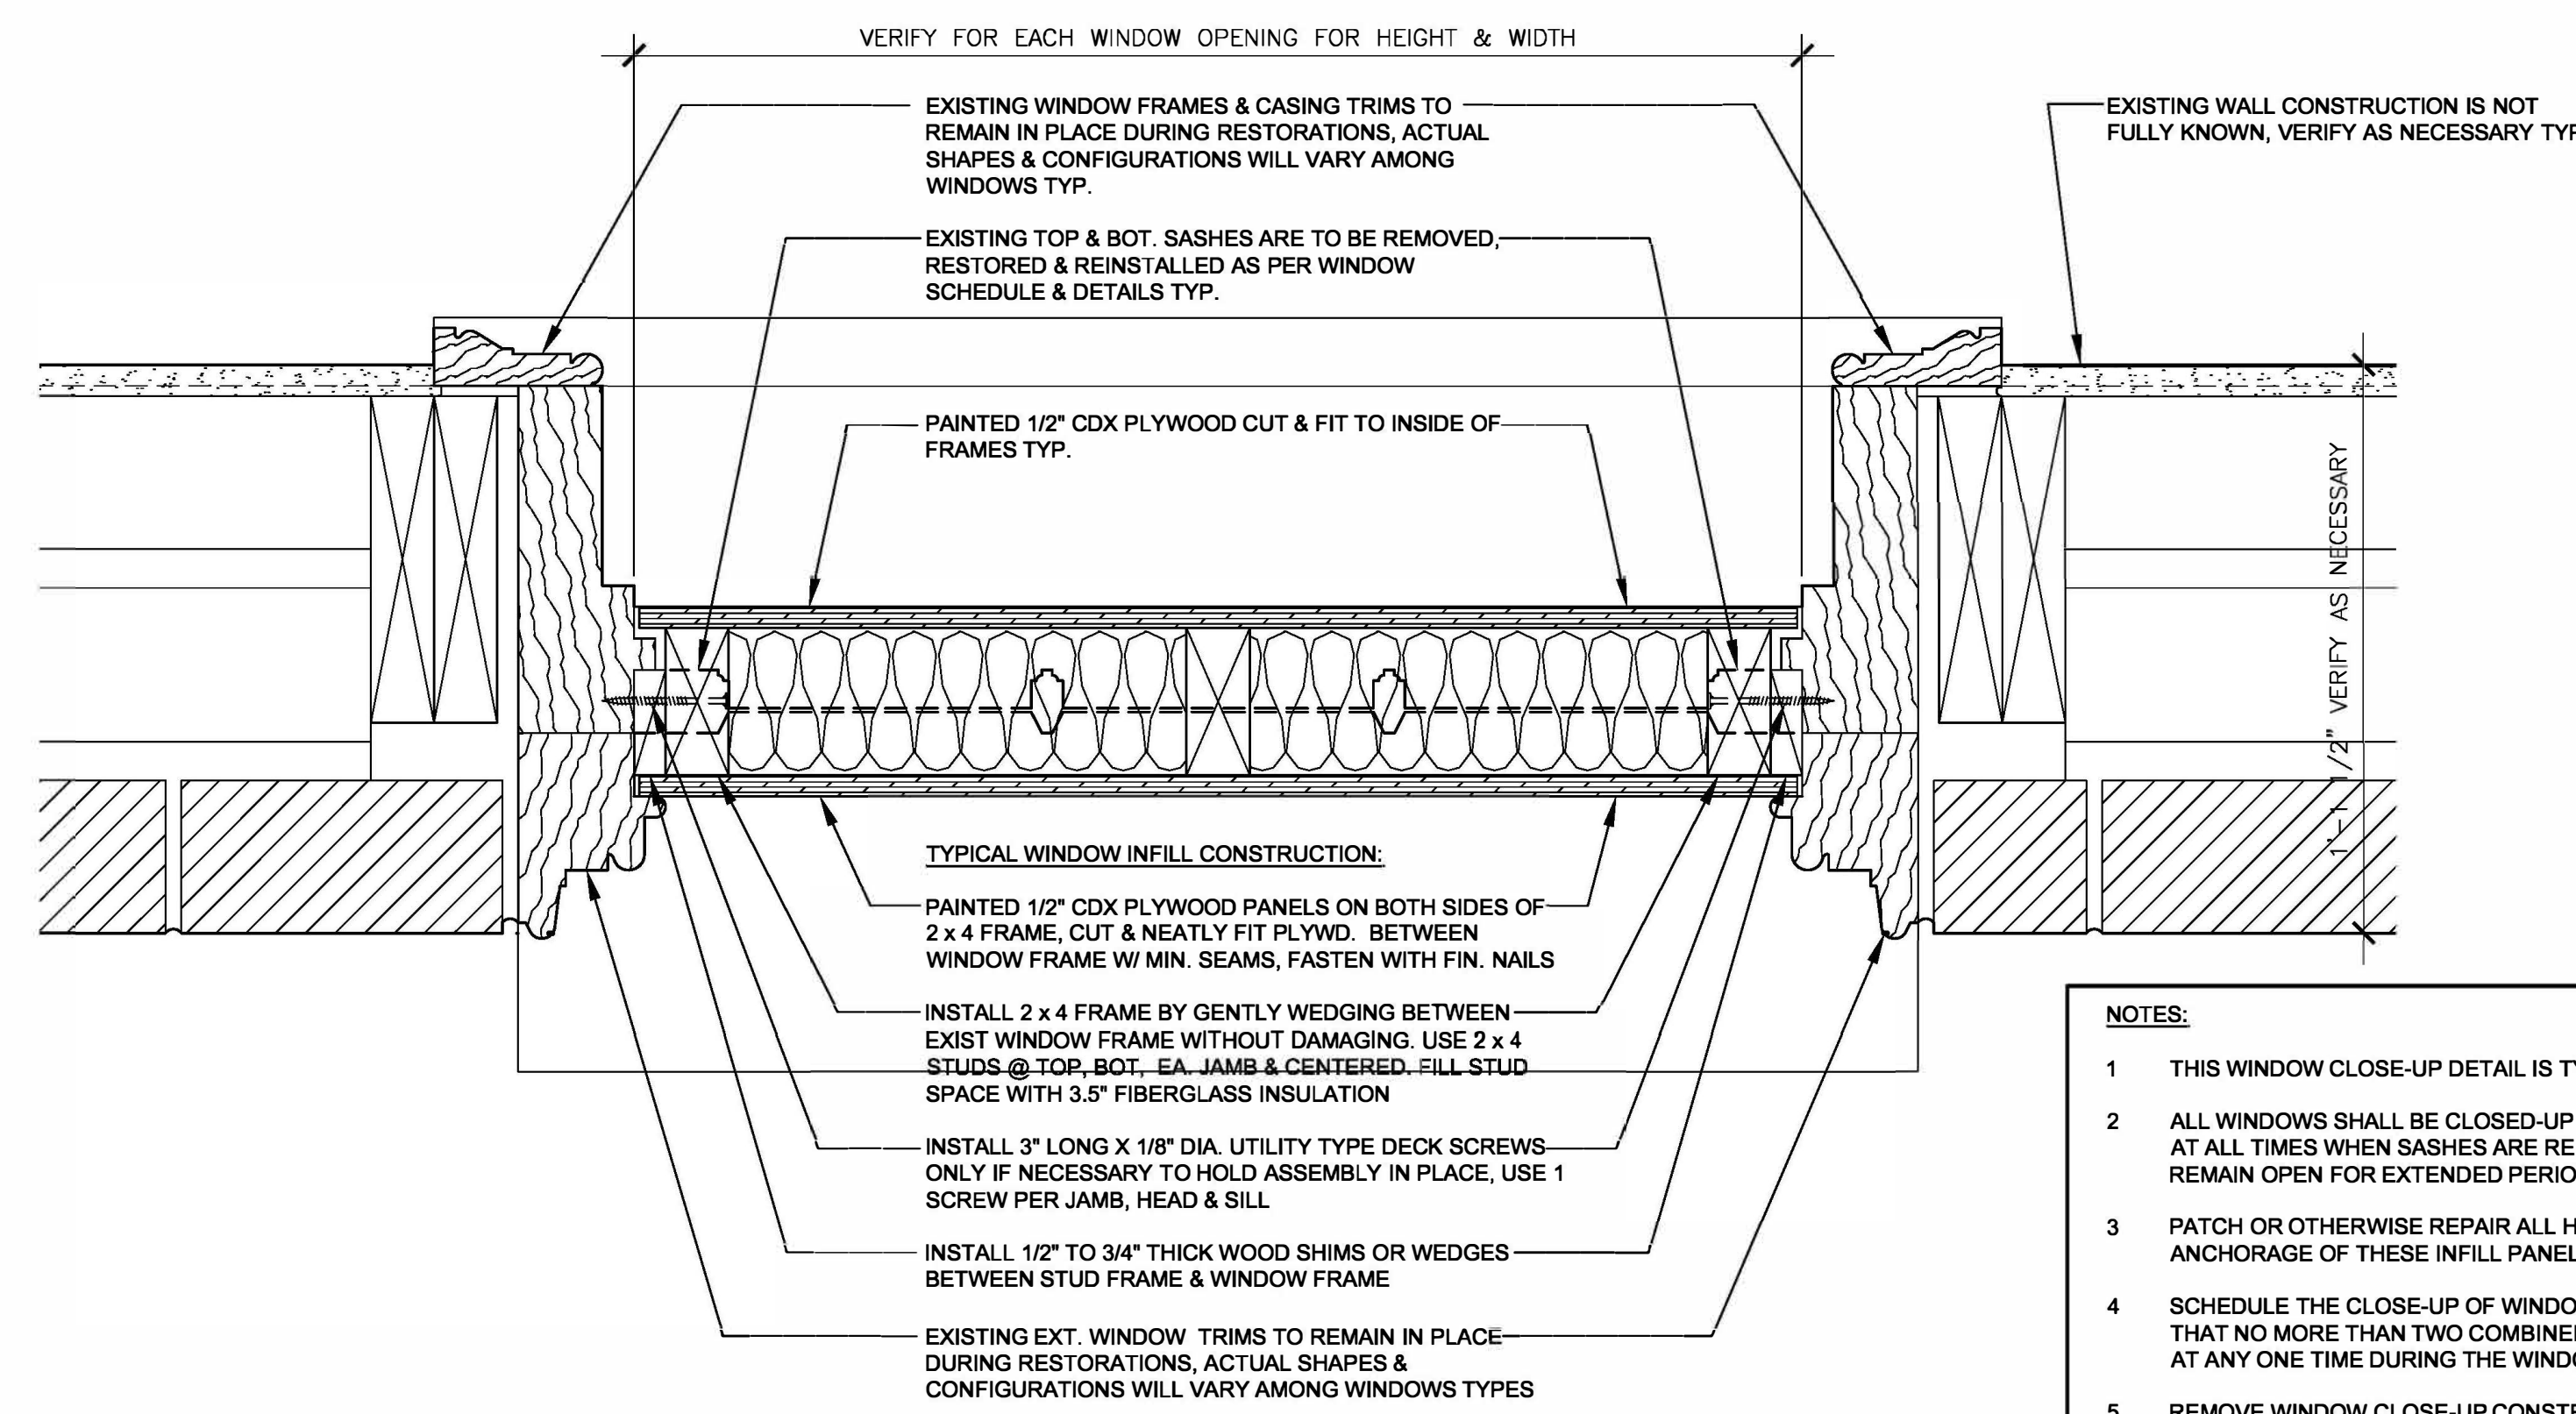
3 TYPICAL WINDOW OPENING CLOSURE
G-002 SCALE: 3"=1'-0"

- NOTES:**
- THIS WINDOW CLOSE-UP DETAIL IS TYPICAL FOR ALL WINDOW OPENINGS.
 - ALL WINDOWS SHALL BE CLOSED-UP TO PROTECT INTERIOR FROM WEATHER AT ALL TIMES WHEN SASHES ARE REMOVED FROM THEIR FRAMES & MUST REMAIN OPEN FOR EXTENDED PERIODS OF TIME.
 - PATCH OR OTHERWISE REPAIR ALL HOLES OR DAMAGE DUE TO TEMPORARY ANCHORAGE OF THESE INFILL PANELS.
 - SCHEDULE THE CLOSE-UP OF WINDOWS IN THE BINGHAM DINING ROOM 105 SO THAT NO MORE THAN TWO COMBINED DBL-HUNG WINDOWS ARE CLOSED-UP AT ANY ONE TIME DURING THE WINDOW RESTORATION WORK.
 - REMOVE WINDOW CLOSE-UP CONSTRUCTION AFTER REPLACEMENT OF SASHES & WHEN NECESSARY TO COMPLETE RESTORATIONS.

- ALL WINDOW OPENINGS SHALL BE CLOSED-UP & INSULATED WHEN NOT ACTIVELY BEING WORKED ON OR UNTIL SASHES ARE FINALLY INSTALLED. SEE WINDOW OPENING CLOSURE DETAIL 3/G002.

- ALL WINDOW OPENINGS SHALL BE CLOSED UP & INSULATED WHEN NOT ACTIVELY BEING WORKED ON OR UNTIL SASHES ARE FINALLY INSTALLED. SEE WINDOW OPENING CLOSURE DETAIL 3/G-002.

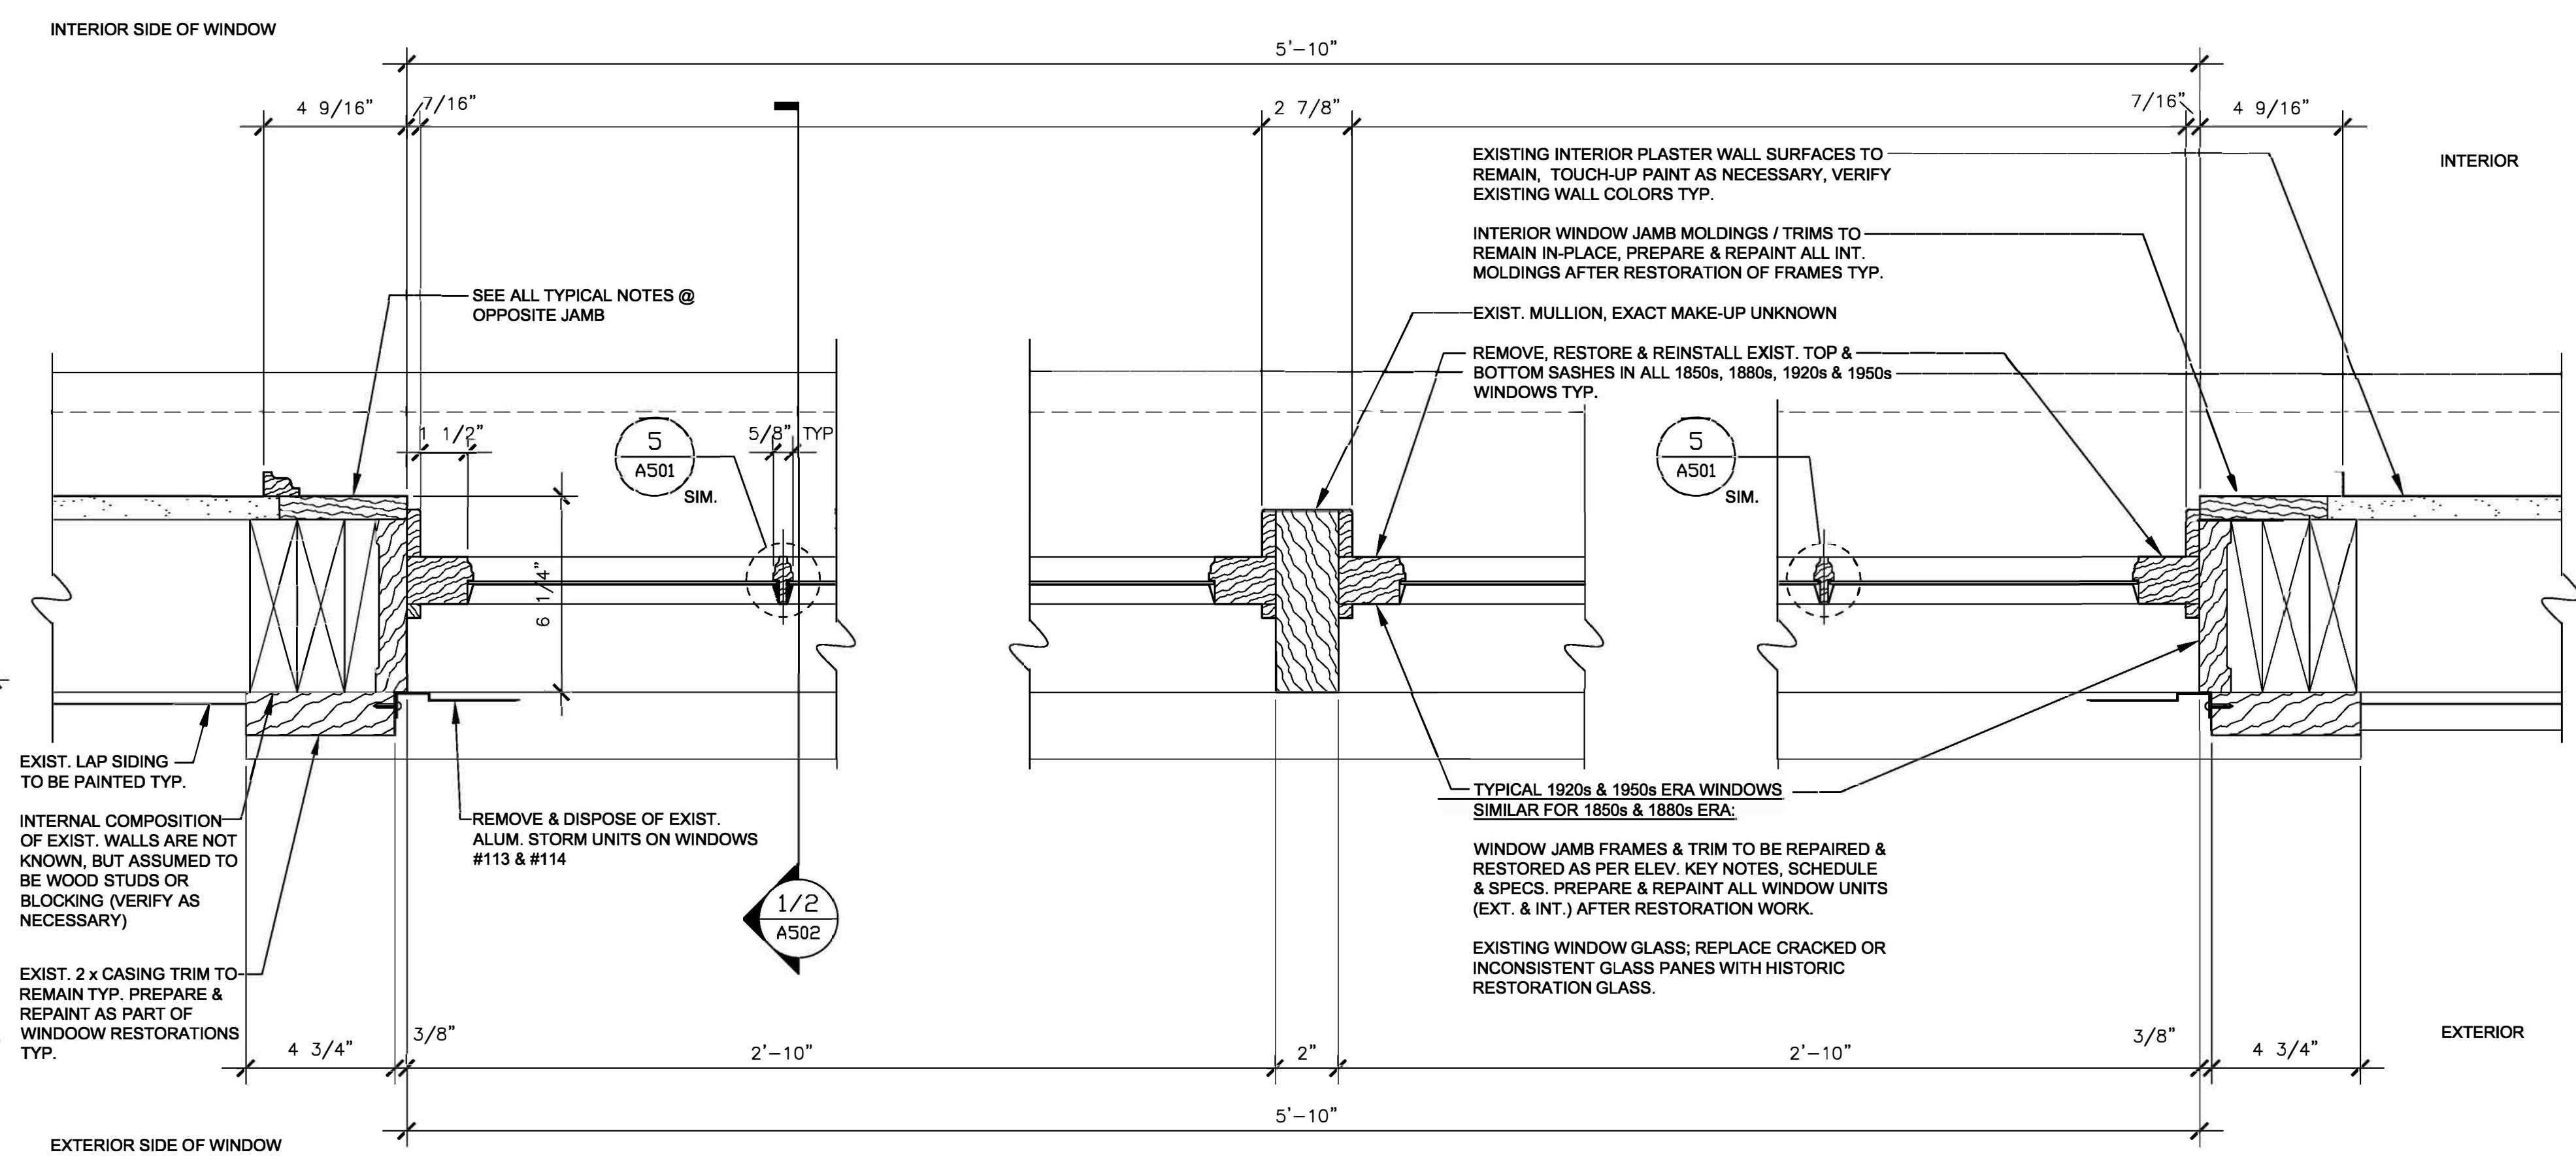
5 WINDOW JAMBS
A-502 SCALE: 3"=1'-0"

6 VERTICAL MEETING MULLION
A-502 SCALE: 3"=1'-0"

7 WINDOW JAMBS
A-502 SCALE: 3"=1'-0"

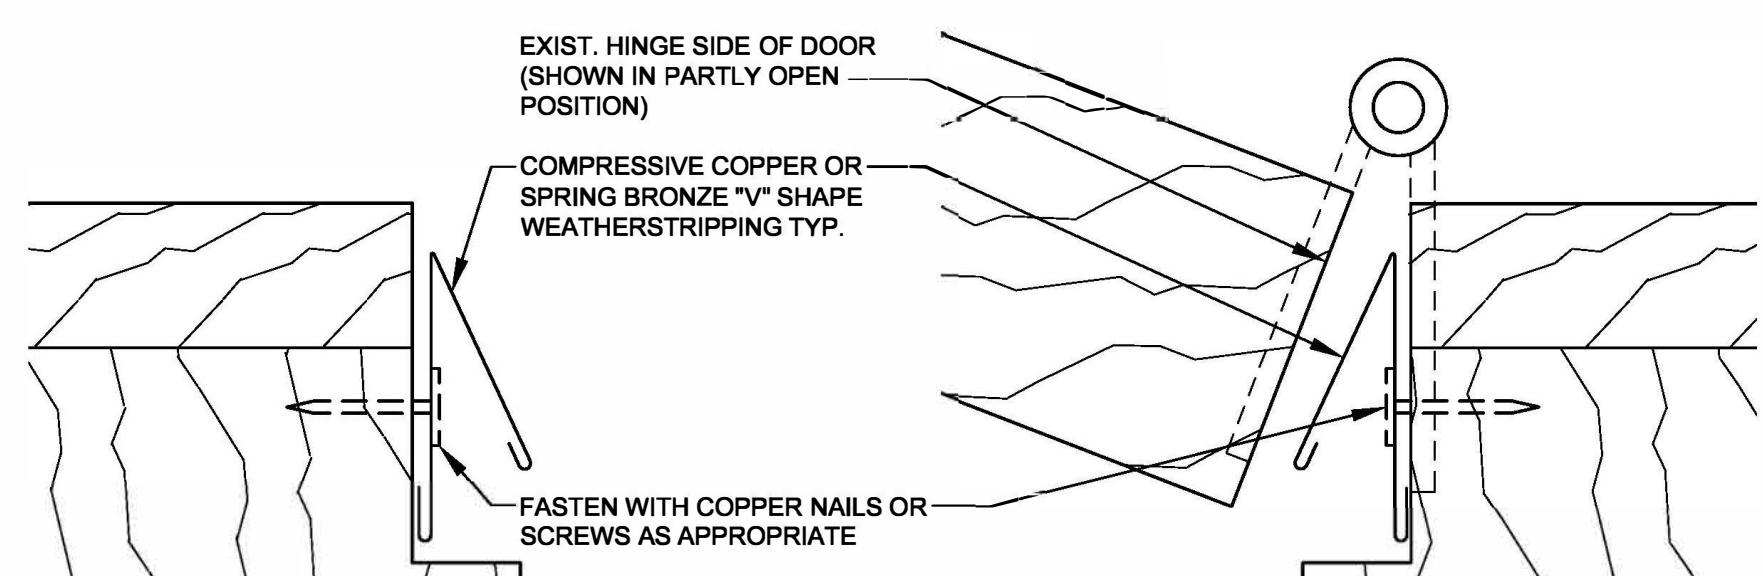
13 TYPICAL COMPRESSION WEATHERSTRIPPING @ JAMBS
A-503 / SCALE: FULL SIZE

- WEATHERSTRIPPING:** ALL DOORS SHALL BE WEATHERSTRIPPED WITH PERIOD CORRECT STRIPPING AS INDICATED.

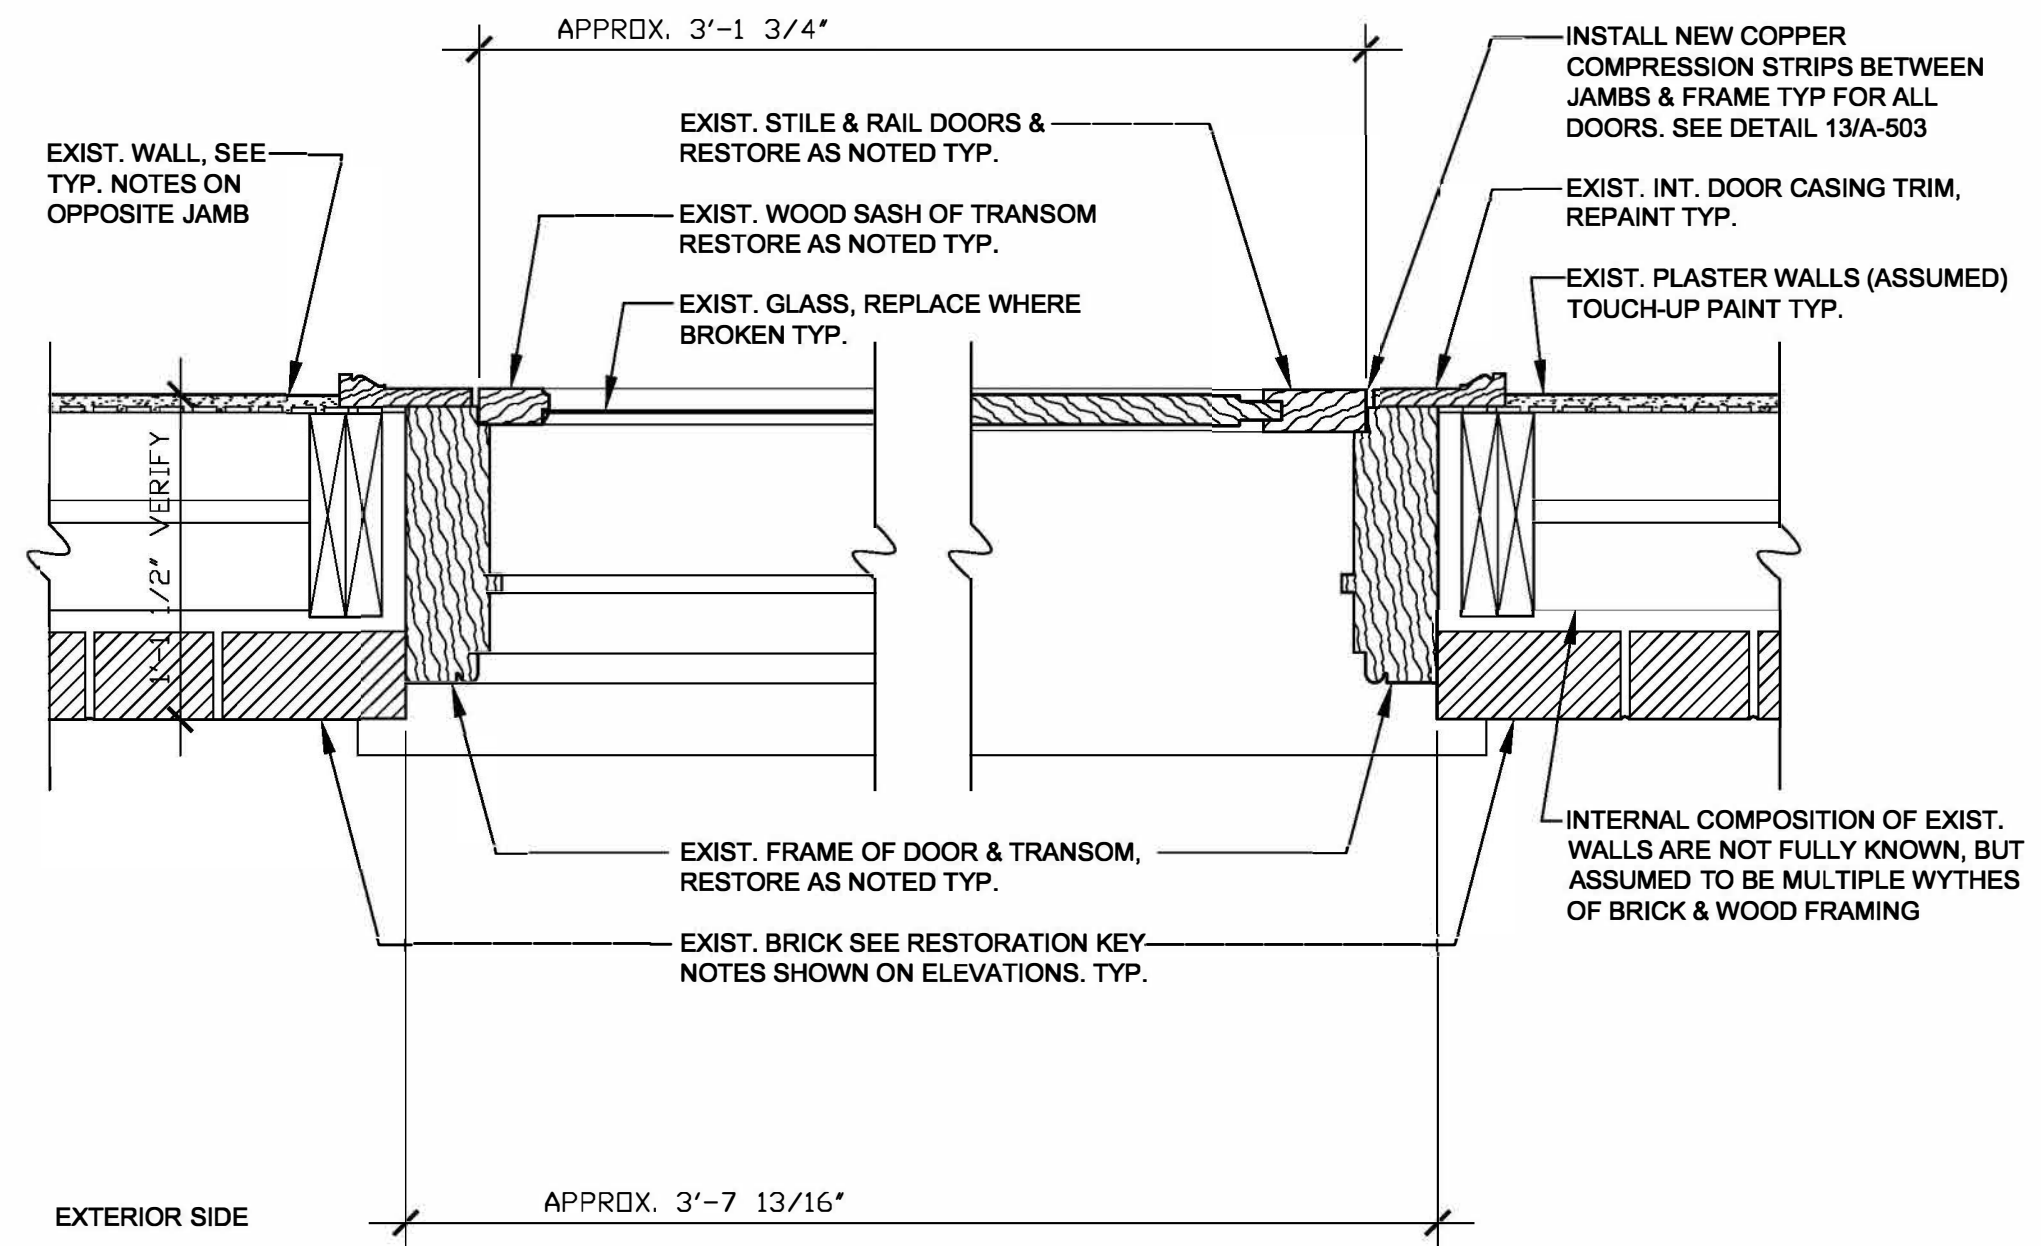
1 TRANSOM JAMBS
A-503 / SCALE: 3"=1'-0"

2 DOOR JAMBS
A-503 / SCALE: 3"=1'-0"

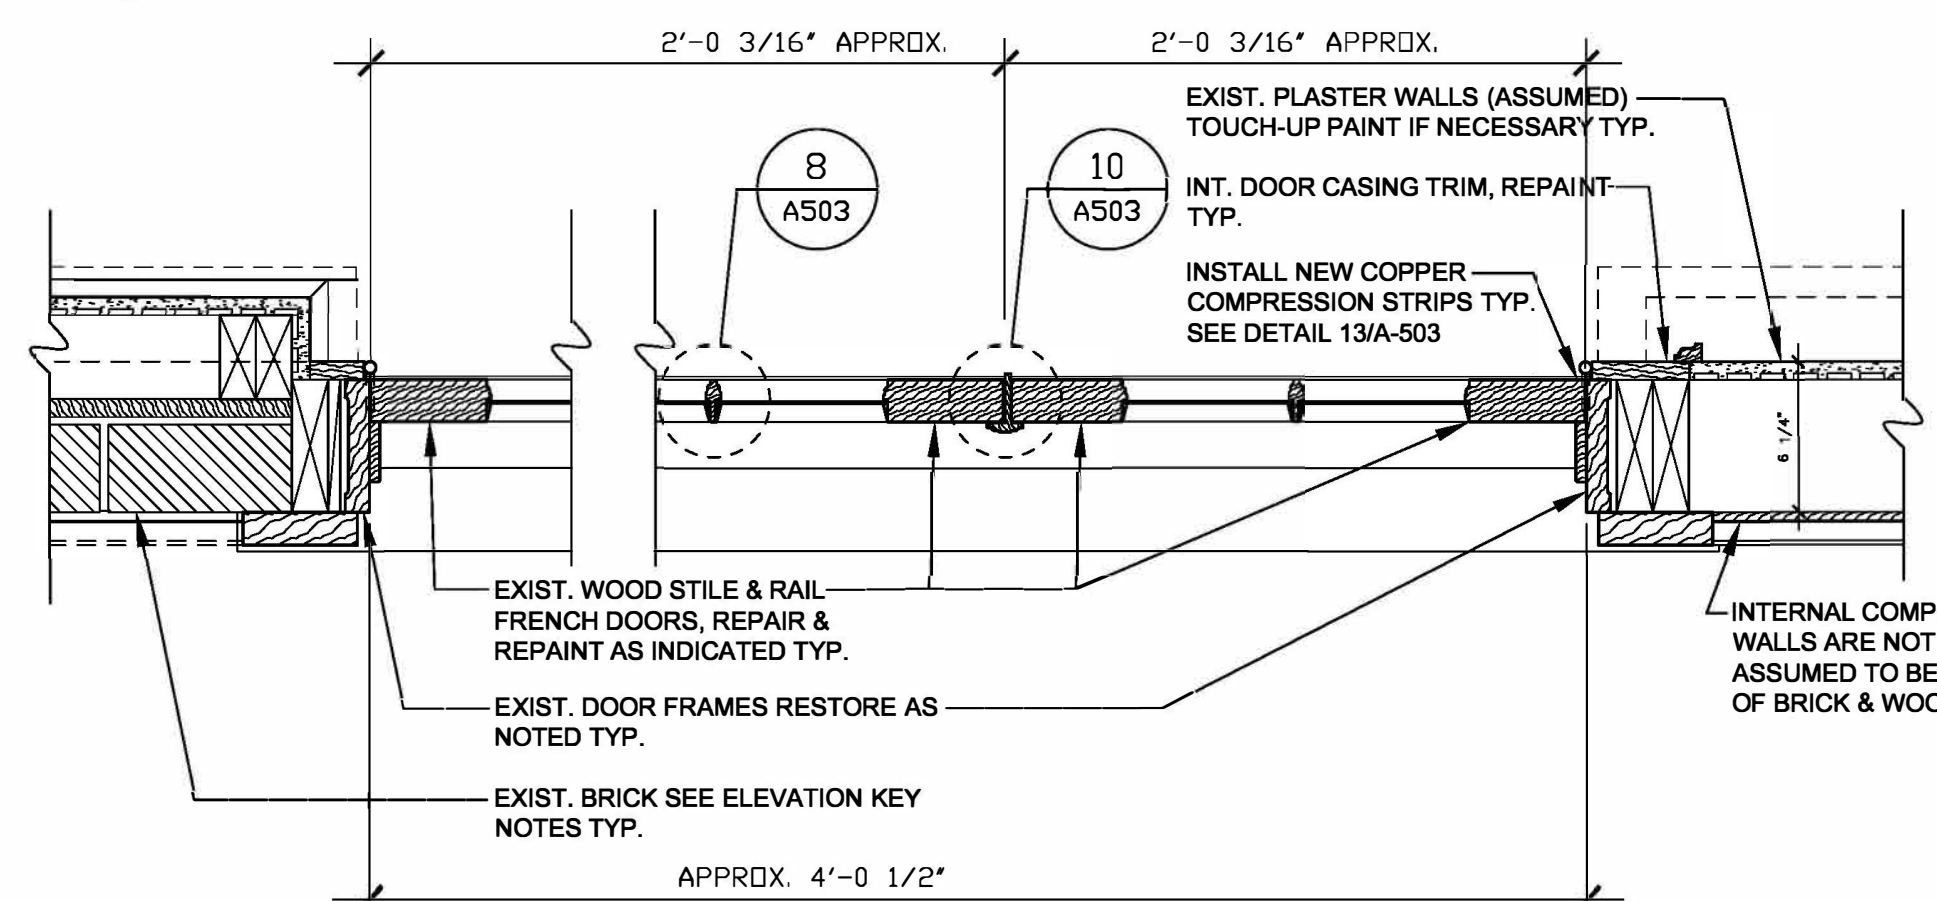
9 DOOR JAMB - LOW SIDE
A-503 / SCALE: 3"=1'-0"

11 DOOR JAMB - HIGH SIDE
A-503 / SCALE: 3"=1'-0"
